JABIRU AIRCRAFT PTY LTD

Engineering Report: AVS4CYL001-1

Subject: Finite Element Analysis Cylinder Head Cracks

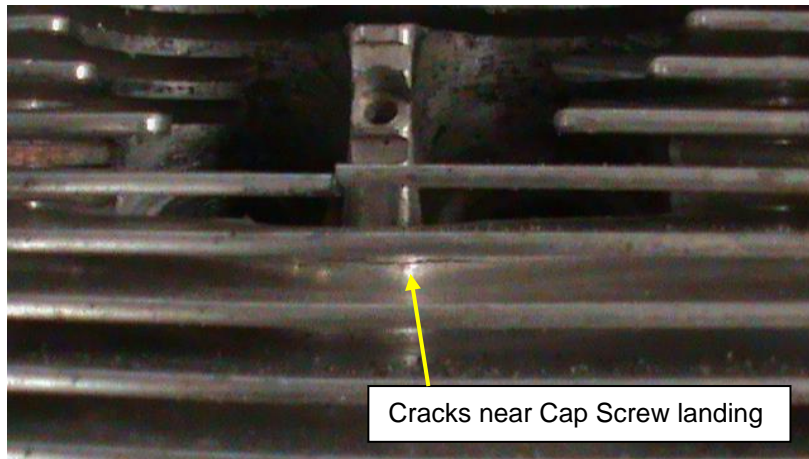
As mentioned the cracks in the Cylinder head occur between the junction between the Cap Screw landing and the adjacent fin. These cracks have been seen to occur on the front three Cap Screw landings and most commonly on the middle one. Figure 1 below shows a cylinder head which had developed one if these cracks

Figure 1 - Cracks in Cylinder Head near Cap Screw landing

It is suspected that these cracks develop simply because the amount of material at these points is very thin. It is therefore likely that the crack develops because of thermal creep, where the cylinder head temperature increases and decreases cyclically causing the thinner material to expand at a different rate to the surrounding thicker material and therefore it 'gets left behind' creating a crack.

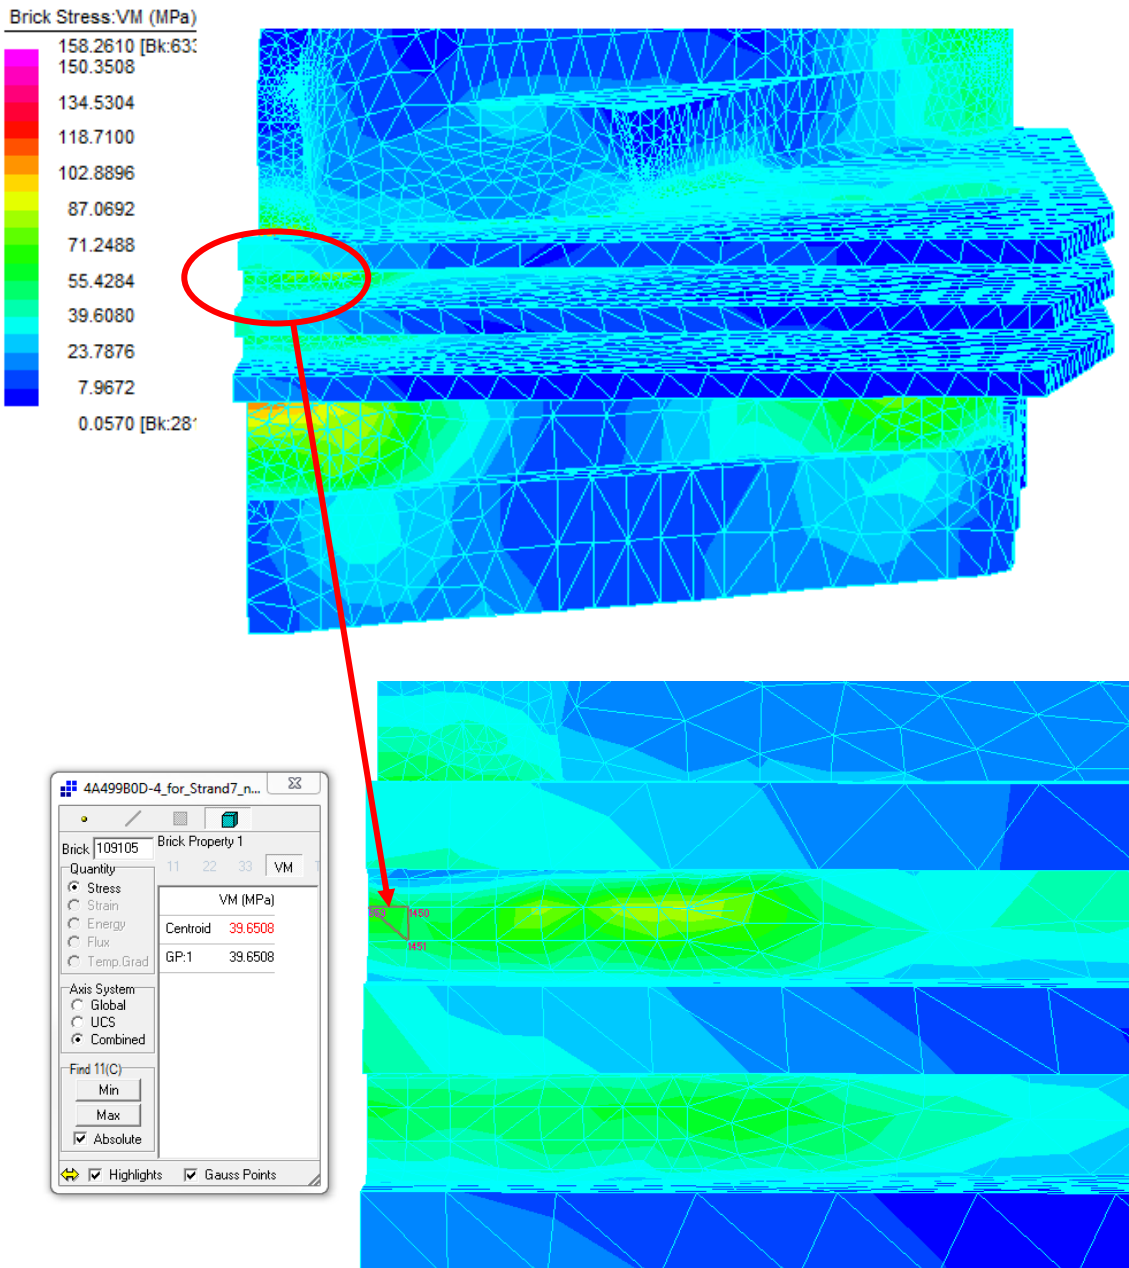
Figure 6 - Stress levels on the front cap screw landing (a place where cracks have been detected)

It can be seen that the stress levels around this area of the cylinder are relatively low as indicated by the light blue colouration. More specifically the magnitude of Von Mises combined stress is only 39.6 MPa.

5083-H112 aluminium alloy has an ultimate tensile strength of 269 MPa (as taken from the MIL5HBK5J). The stress level in the area where these cracks have been observed is only 15% of the Ultimate tensile stress. This is too low to be the reason for the crack initiating in the first place and also too low to cause the crack to propagate.

From FEA analysis it was found that the stress level where these cracks had been found is too low for pure overstress to be responsible. Therefore the crack had developed due to thermal creep. The level of stress is also too low for the cracks to propagate. From analysis conducted these crack do not present a threat to the cylinder head structural integrity or the integrity of the engine as a whole.
