SERVICE LETTER: JSL 014-2

Date: 5th August, 2015

Subject: Jabiru Cylinder Head Inspection

Affected Models: All Jabiru Engines

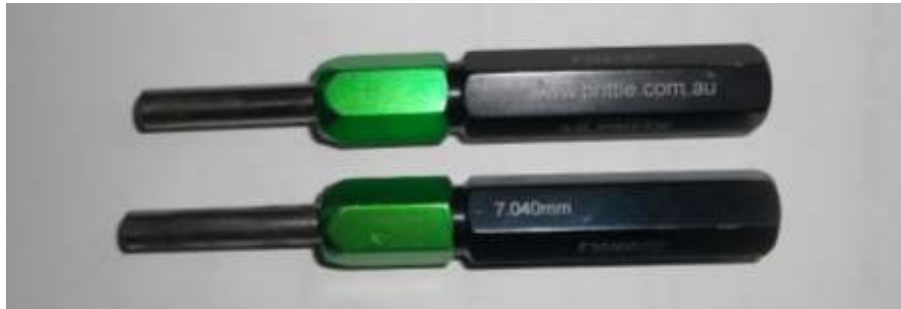
- iii. Inspect the valve guides. Check there is not excessive carbon build-up. Check the diameter of the guide is within the limits specified in the build tolerances table in JEM0001. Use a 'Go-No Go' tool (as pictured below – Available from www.prittie.com.au - Part Number TSA7.1G 7.040mm). Ream out guide if required to meet the tolerances specified in the Engine Overhaul Manual (JEM0001). A high quality adjustable straight reamer should be used (e.g. the Sutton MA8 6.35 – 7.15mm). The procedure of measuring and reaming valve guides requires extensive skill and experience as well as specialized tools. As noted in Section 7, only appropriately trained and approved personnel must carry out these tasks.

Figure 1: Go-No Go Gauges

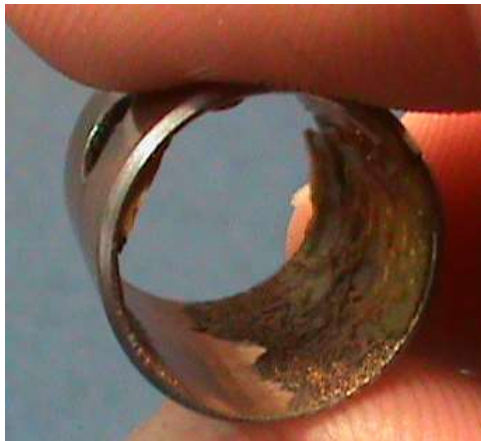
- viii. Inspect rockers. In particular inspect the condition of the rocker bushes, check the bush for melting or other deterioration. Insert the rocker shaft and check that the rocker moves freely (but not loosely) on the shaft. Replace rocker bushes with new parts if required. In the photograph below the rocker bush has most of the inner lubricant material melted away. All yellow rocker bushes from all cylinder heads should be replaced. Report to Jabiru using Continued Operating Safety Form COSM-1 below.

Figure 3: Badly worn rocker bush.

- vii. Rocker bush wear. May be caused by elevated head, oil or exhaust temperatures. Troubleshoot as noted above.

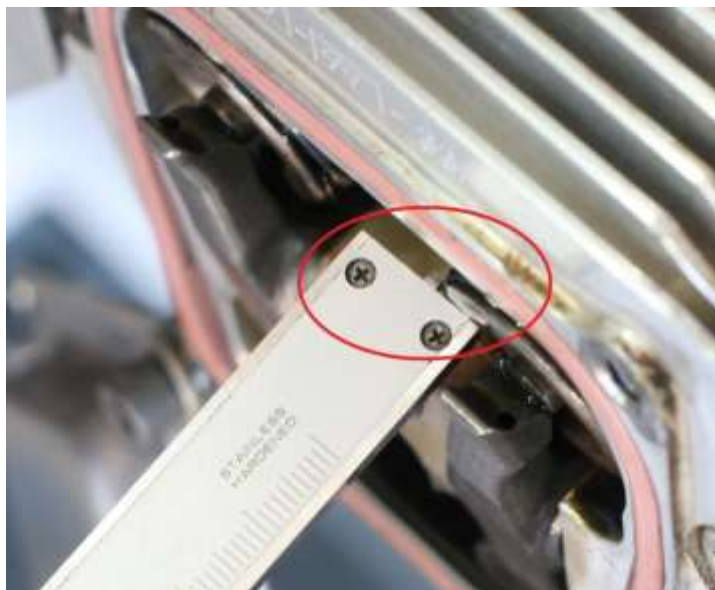
- Remove the rocker covers from all heads (see Head Bolt Tension JEM0002 Jabiru Maintenance Manual).
- Set depth vernier at 1.5mm and compare with the top spring washer and look for any signs indicating wear. If signs are present, proceed with **5.1 Cylinder Head Removal and Inspection**. Also refer to JSL-008 21st Dec 2012.

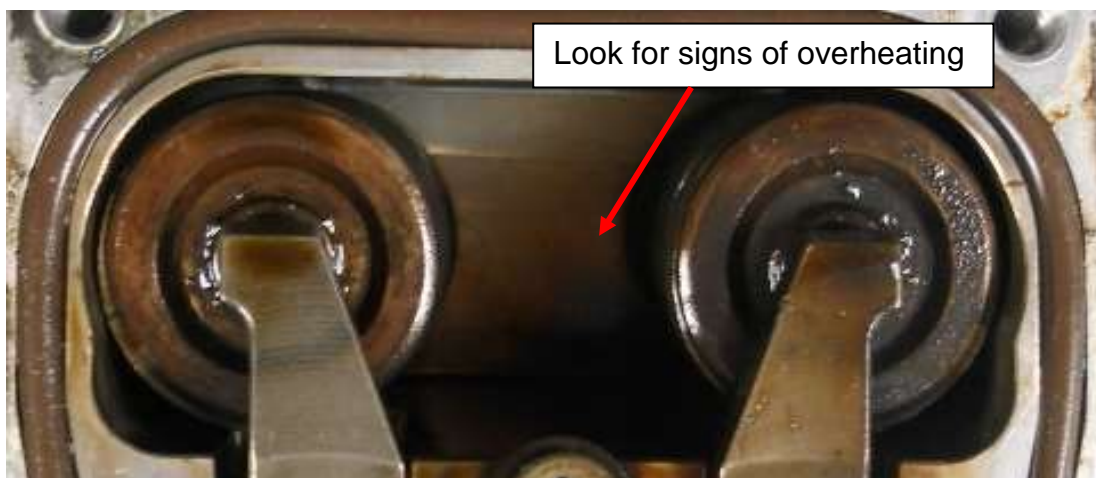
- Look for signs of overheating. If signs are present, proceed with **5.1 Cylinder Head Removal and Inspection**.
