SERVICE LETTER: JSL 014-1

Subject: **Jabiru Cylinder Head Inspection**

Affected Models: **All Jabiru Engines**

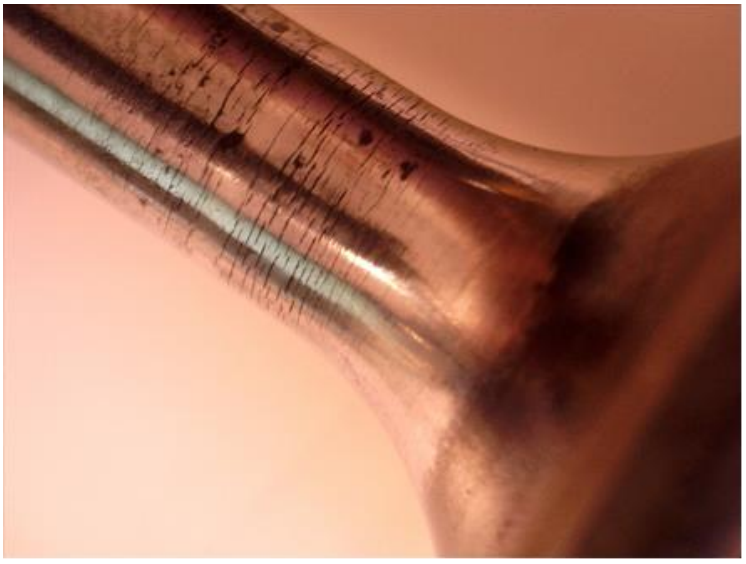
iv. Inspect both valves, checking for corrosion and abrasion on the stem. Inspect the bottom of the stem using a 10X magnifying glass. This area will first need to be polished clean (using non-abrasive methods to avoid damaging the valve) so the surface can be inspected. Check the stem for bluing and transverse stress cracks which would indicate overheating. If cracks are found then all valves in the engine must be replaced. (See Figure 2). Report to Jabiru using Continued Operating Safety Form COSM-1 below.

Figure 2: Valve with extensive stress cracks.

iii. Valve stem cracking. Typically due to operation at excess exhaust gas temperatures. Check EGT using EGT sensors such as a fully instrumented EMS (contact Jabiru Aircraft for more information). Check for leaks in intake/exhaust system. Check carburettor settings and mixtures. Check fuel freshness. Check valve is sealing.
