JABIRU AIRCRAFT PTY LTD

Engineering Report: AVS4CYL001-1

Subject: Finite Element Analysis Cylinder Head Cracks

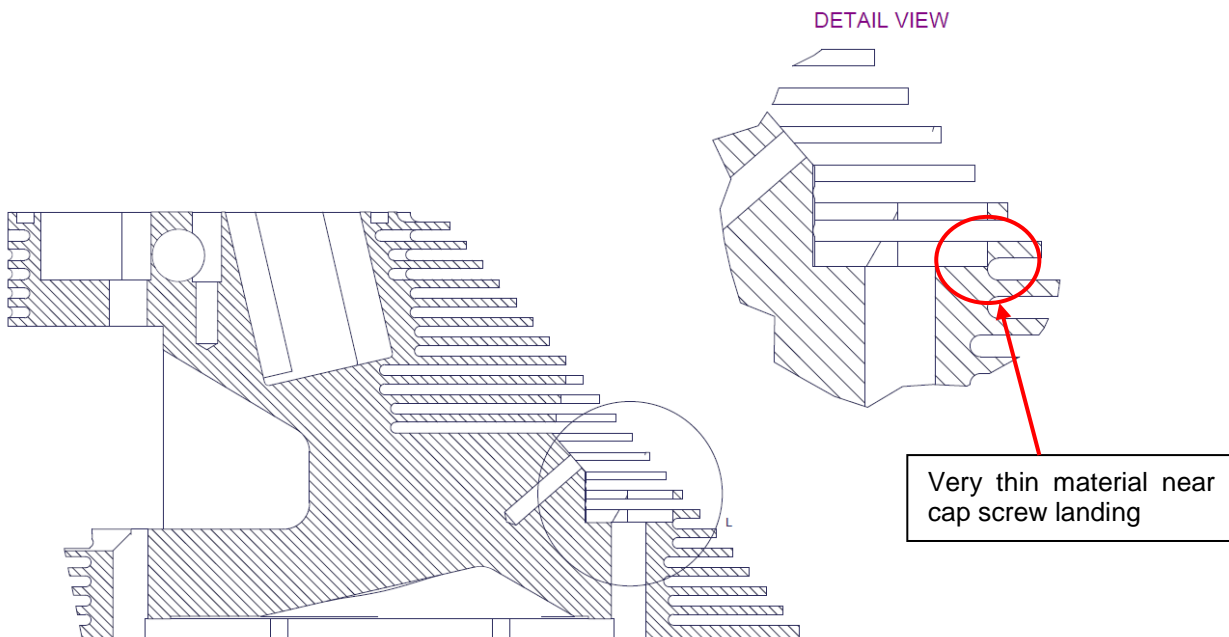
Figure 2 - Details of the Cap screw landing of the Cylinder heads

As mentioned the cracks in the Cylinder head occur between the junction between the Cap Screw landing and the adjacent fin. These cracks have been seen to occur on the front three Cap Screw landings and most commonly on the middle one. Figure 1 below shows a cylinder head which had developed one if these cracks

It is suspected that these cracks develop simply because the amount of material at these points is very thin. It is therefore likely that the crack develops because of thermal creep, where the cylinder head temperature increases and decreases cyclically causing the thinner material to expand at a different rate to the surrounding thicker material and therefore it 'gets left behind' creating a crack.

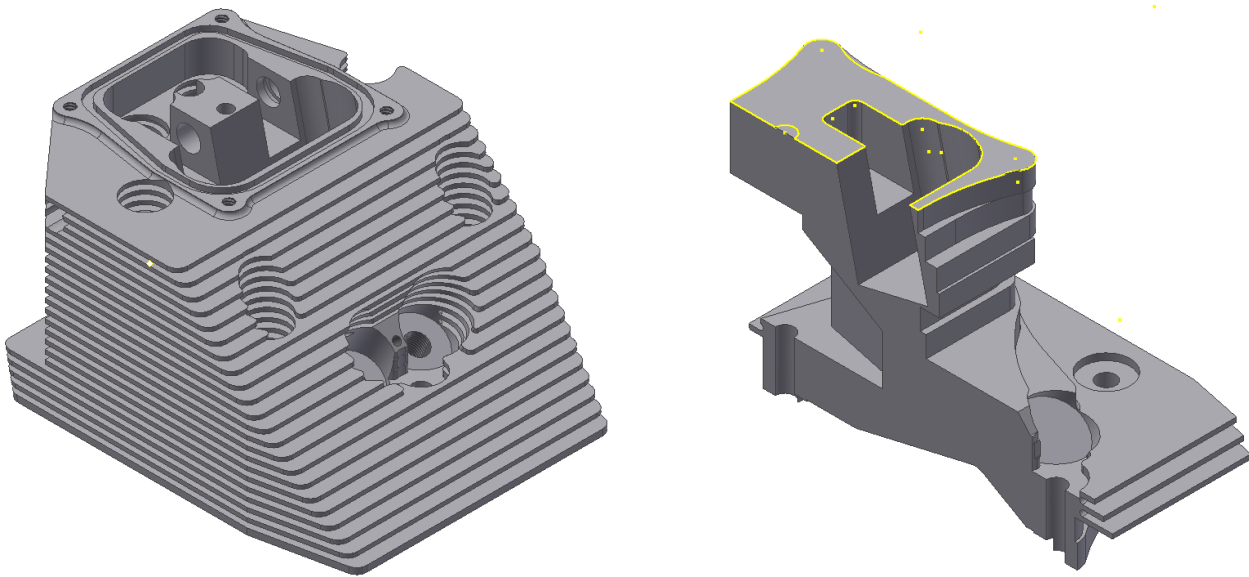
Figure 3 - Cylinder Head model (left) was simplified (right) for FEA

The accuracy and speed of FEA is very much dependant on reducing the number of elements in the model by removing un-necessary details and other simplification techniques. Beginning with the CAD model for the 2200 cylinder head (P/No 4A499B0D-4) the following simplifications were made

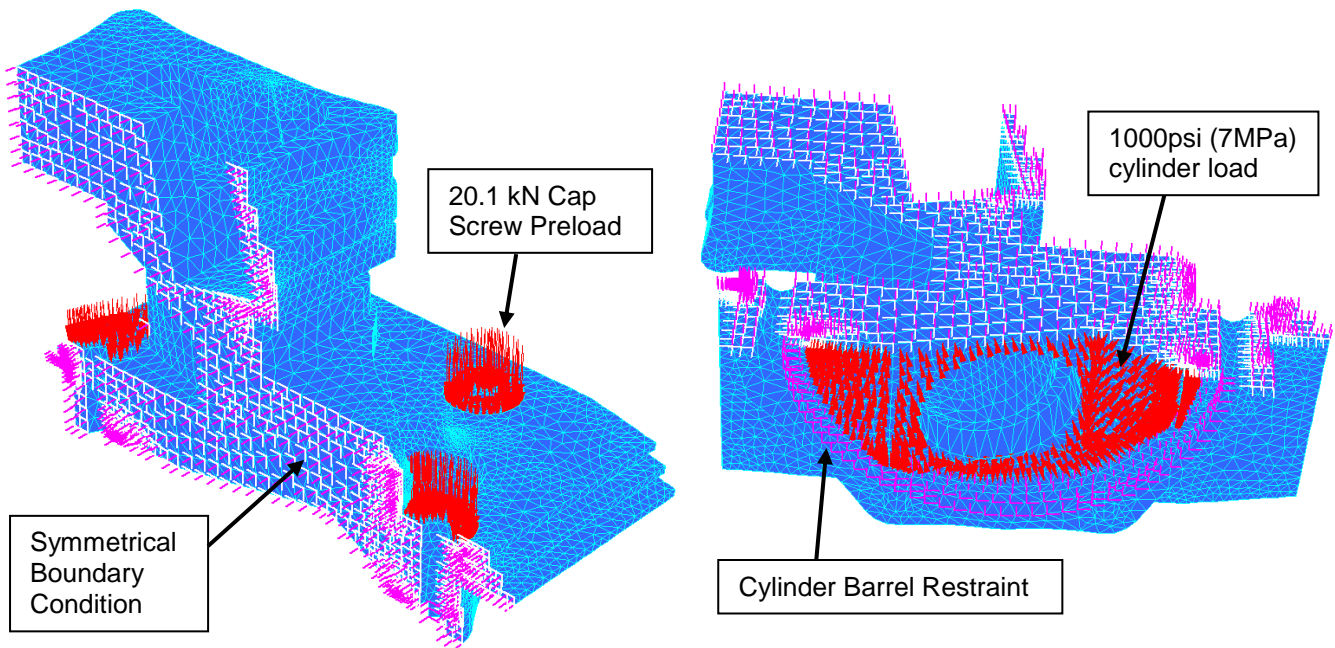
Figure 4 - Cylinder Head FEA mesh, Loads and Boundary Conditions

On the cut face, symmetrical boundary conditions were used. On the bottom of the cylinder head model, restraints on the barrel butting face and the barrel concentric face were placed to represent the support from the barrel.

Cap Screw preloads were applied to the Cap screw landing faces in the form of a surface pressure distributed over the entire circular landing. The pressure used was 76.3 MPa which is equivalent to a 20.1 kN cap screw preload. This preload tension is achieved for a torque setting of 24 ft.lb when the 5/16" cap screw is installed.

On the bottom surface of the cylinder model a pressure load of 7 MPa was applied. This is equal to 1000 psi, which is the highest combustion chamber pressure that Jabiru Engines operate at for the given compression ratio.
